ISIS Reports

Satellite Image Shows Damage to Reactor Buildings at Fukushima Daiichi Complex After Explosions

March 14, 2011

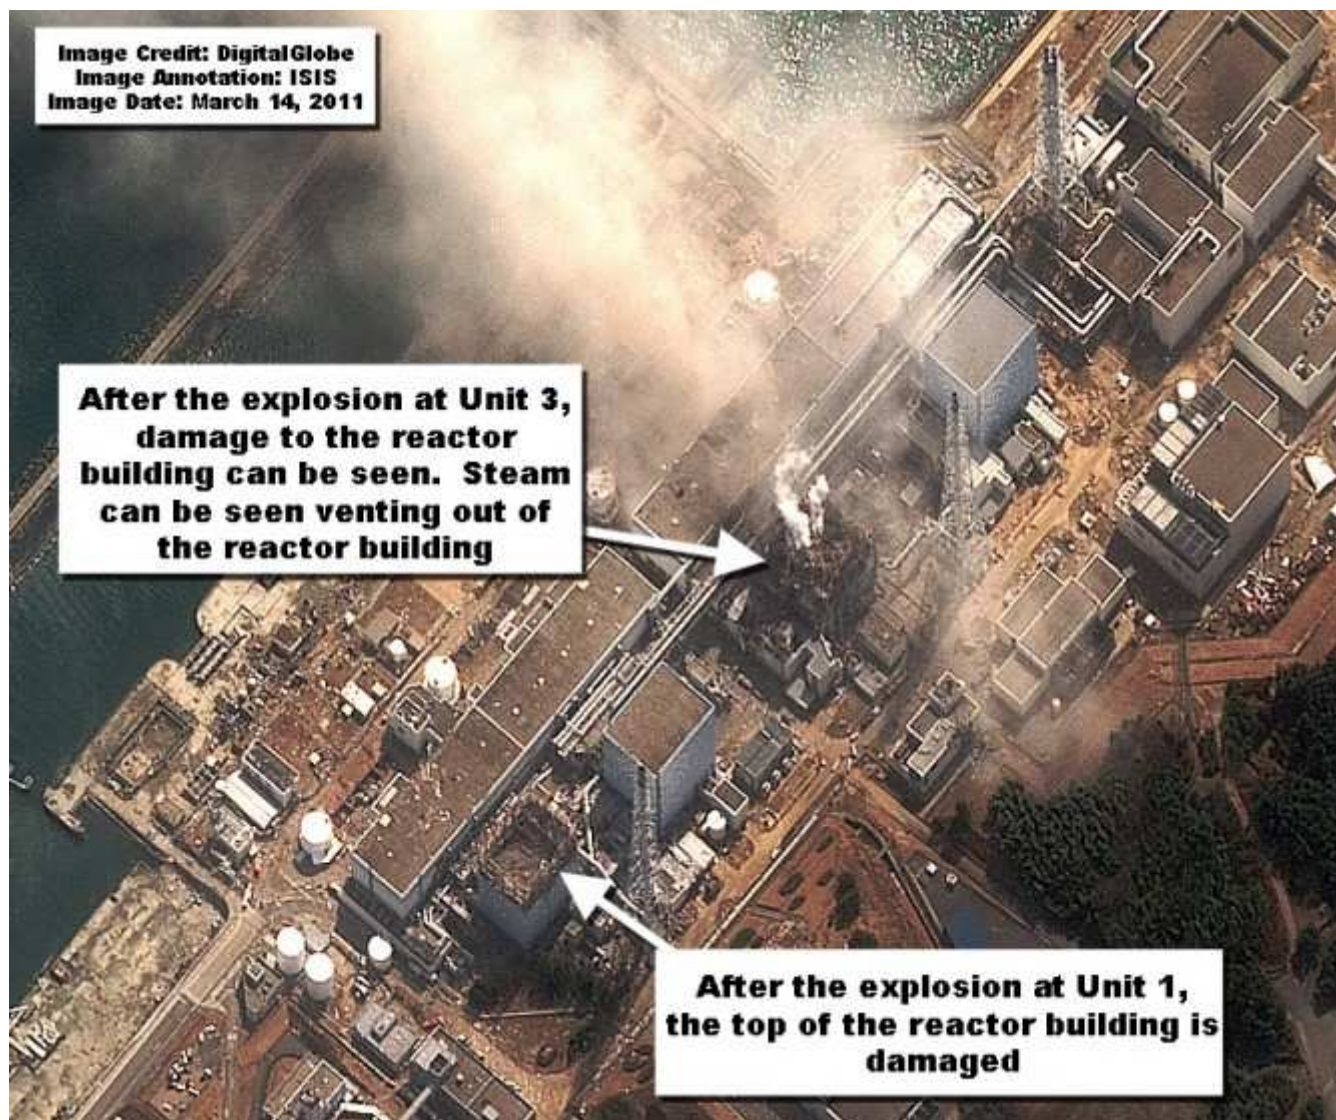
Figure 1. DigitalGlobe image from March 14, 2011 of the Fukushima Daiichi reactor site. Damage to the reactor buildings for Units 1 and 3 can be seen in this image. Steam can be seen venting out of the reactor building for Unit 3.

DigitalGlobe has released a commercial satellite image showing the Fukushima Daiichi reactor complex taken on March 14, 2011. Damage to the top of the reactor building for Unit 1 as well as damage to the reactor building for Unit 3 following the explosions can be seen (see figure 1). Steam can be seen venting out from the reactor building for Unit 3.
